PHASE I INSPECTION REPORT

**WALLACE CREEK BASIN
WALLACE CREEK DAM
CLINTON, MONTANA
MT-1158**

**MORRISON - MAIERLE, INC.
CONSULTING ENGINEERS**

APRIL, 1981

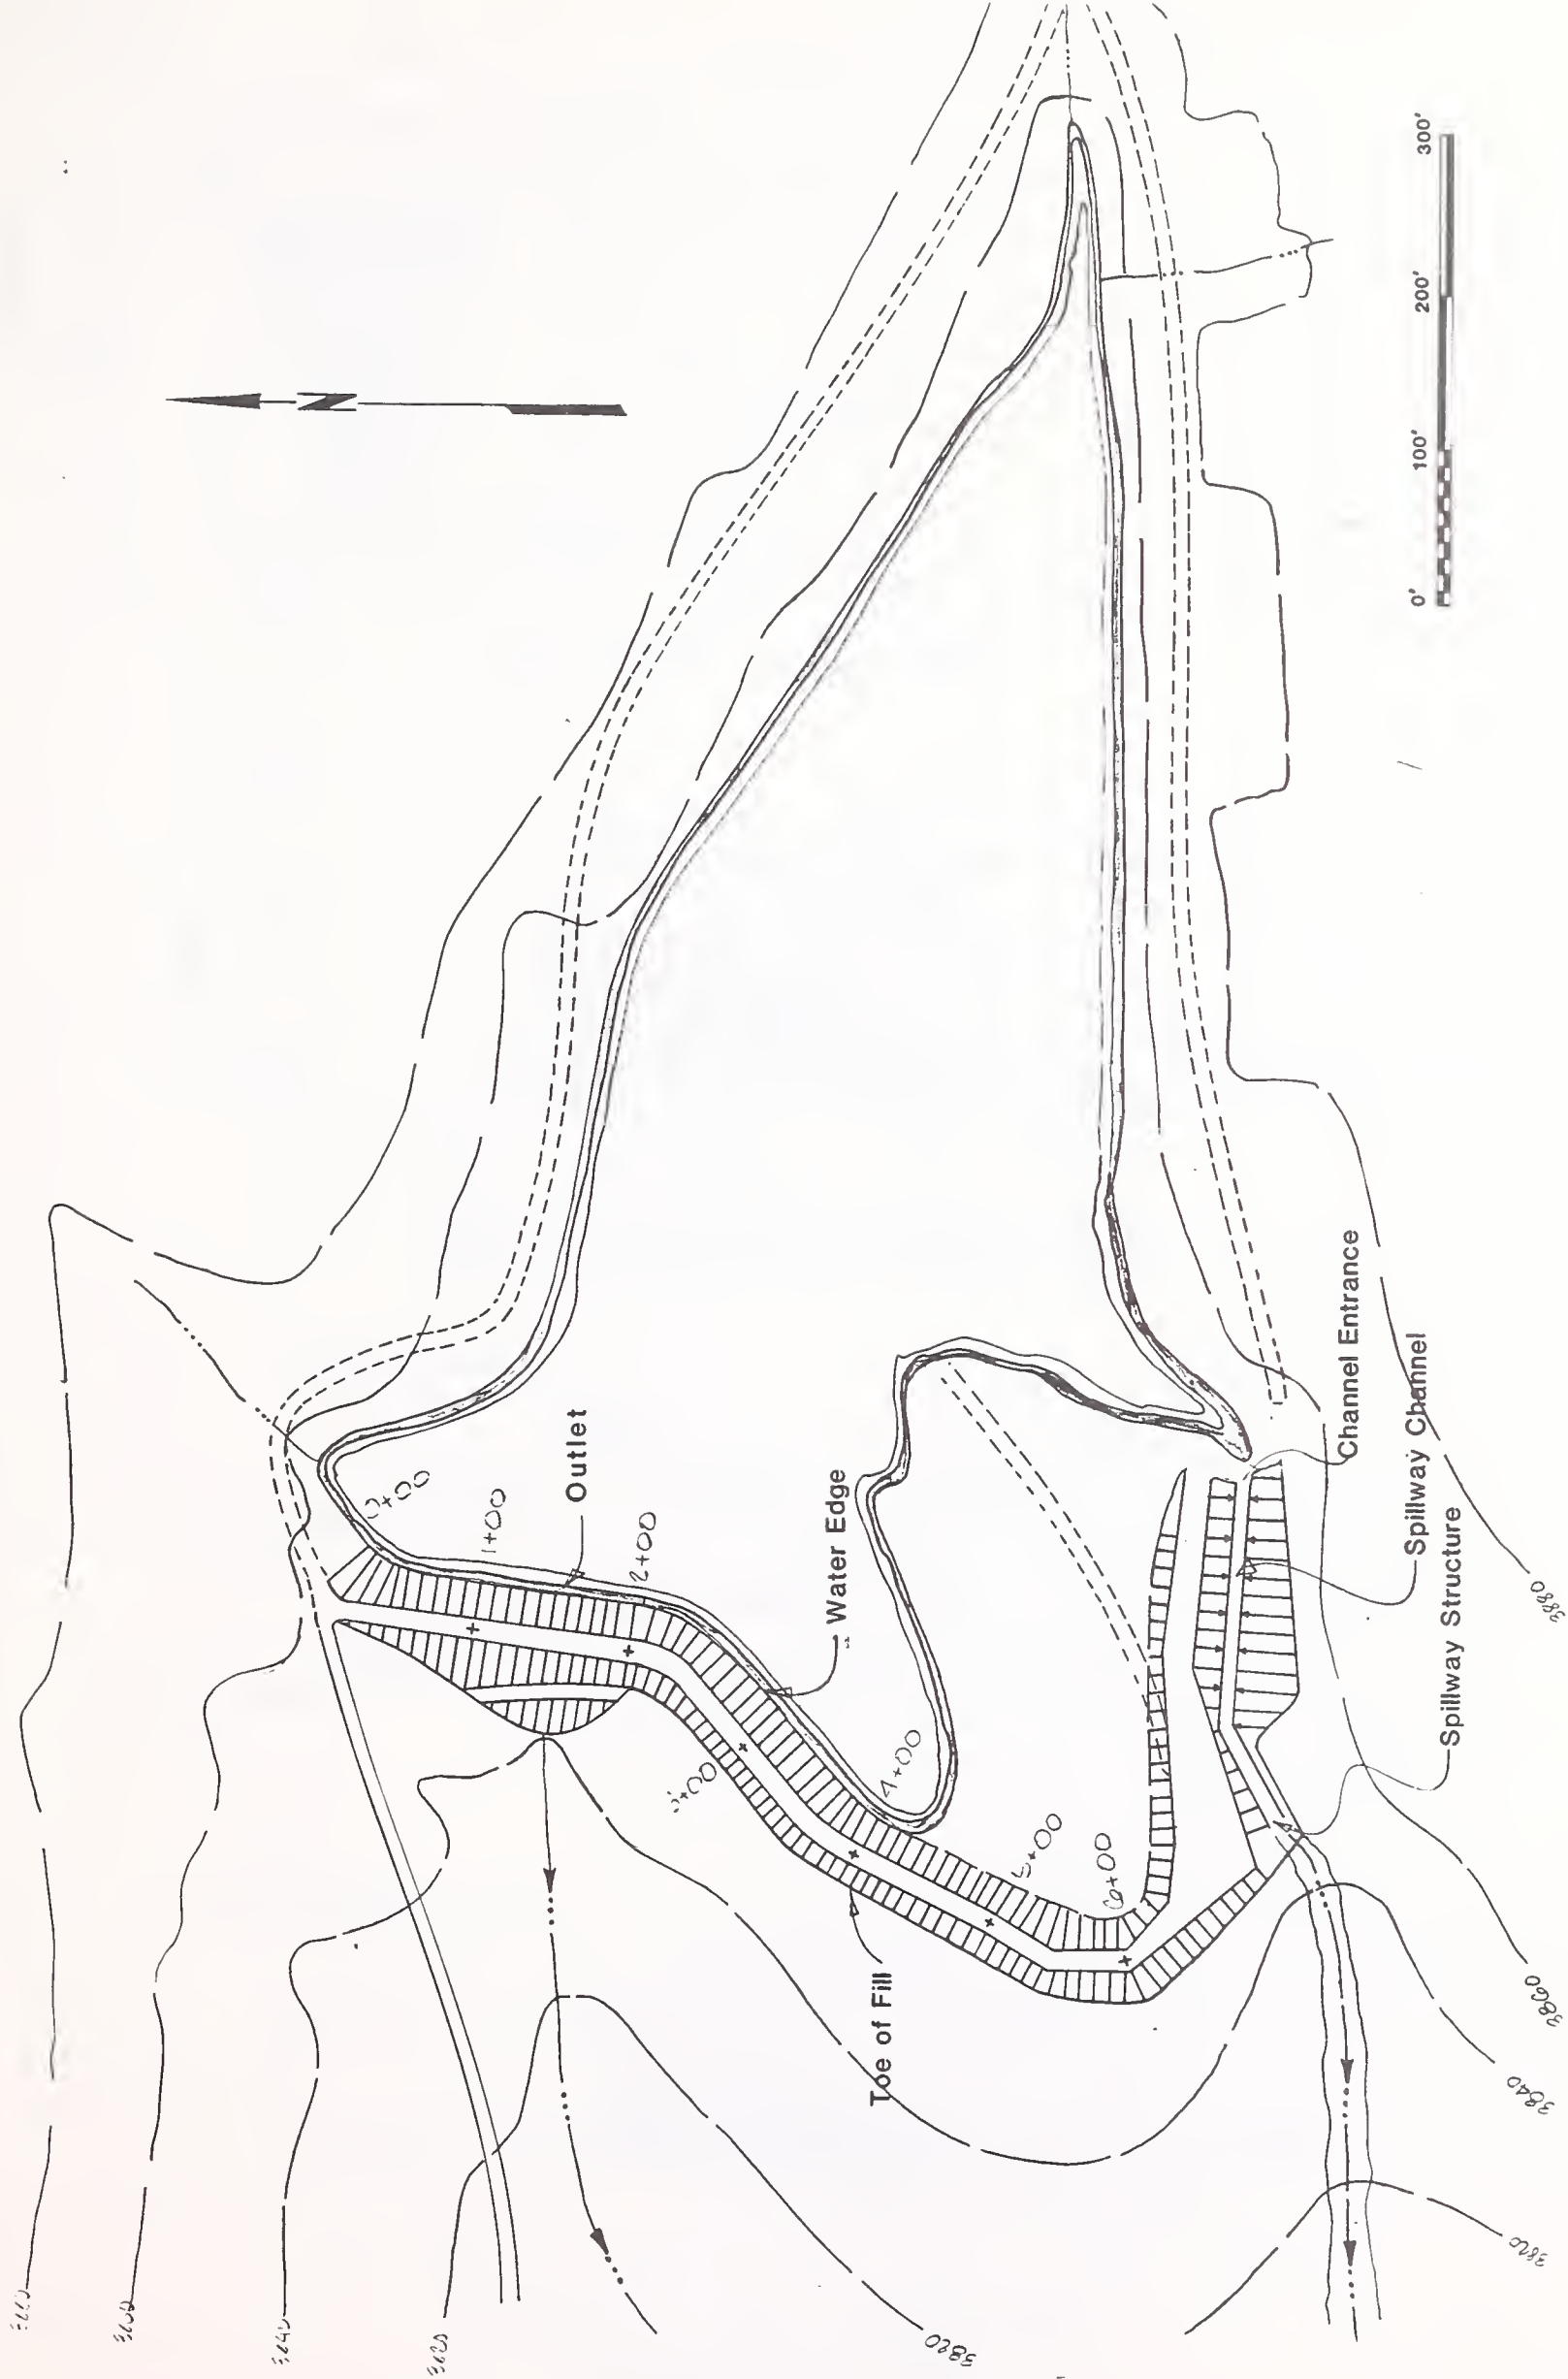
PLATE 3
WALLACE CREEK DAM SITE PLAN

The dam consists of a main embankment about 240 feet long and a dike approximately 10 feet high which extends for an additional 480 feet to the spillway. (See Plate 3).

The spillway for Wallace Creek Dam is located in natural ground just beyond the south abutment (See Plate 3 and Photos 7 through 11). The spillway consists of an unlined chute excavated in a heterogeneous landslide mass consisting of angular quartzite fragments set in a sandy matrix (Plate 5). There is a control structure located 225 feet downstream of the spillway entrance which consists of four 24-inch diameter by 15-foot long corrugated metal pipe (CMP) culverts set in concrete (Photo 8). The assumed elevation of the top of the culverts is 3895.2 feet NGVD and the flow line of the culverts is at elevation 3893.2 feet which is 5.2 feet lower than the minimum elevation of the dam crest. The chute is approximately 225 feet long from the entrance at the reservoir to the culverts with an adverse slope. The cross-section is generally trapezoidal but has a rectangular bottom section 10 feet wide and eight feet deep (Plate 5). Downstream of the culverts, the discharge channel is on a very steep slope of approximately 32 percent and is highly erodible. The concrete weir-culvert section was probably installed to check the headward erosion in the channel. Immediately downstream of the culverts, car bodies and large rock and debris have been placed to reduce erosion. Erosion in the discharge channel or the spillway chute poses no threat to the stability of the dam. The discharge channel joins the Wallace Creek channel approximately 0.25 miles downstream of the dam. The downstream reaches of the discharge channel have eroded to bedrock and erosion in this area would not be expected to continue.

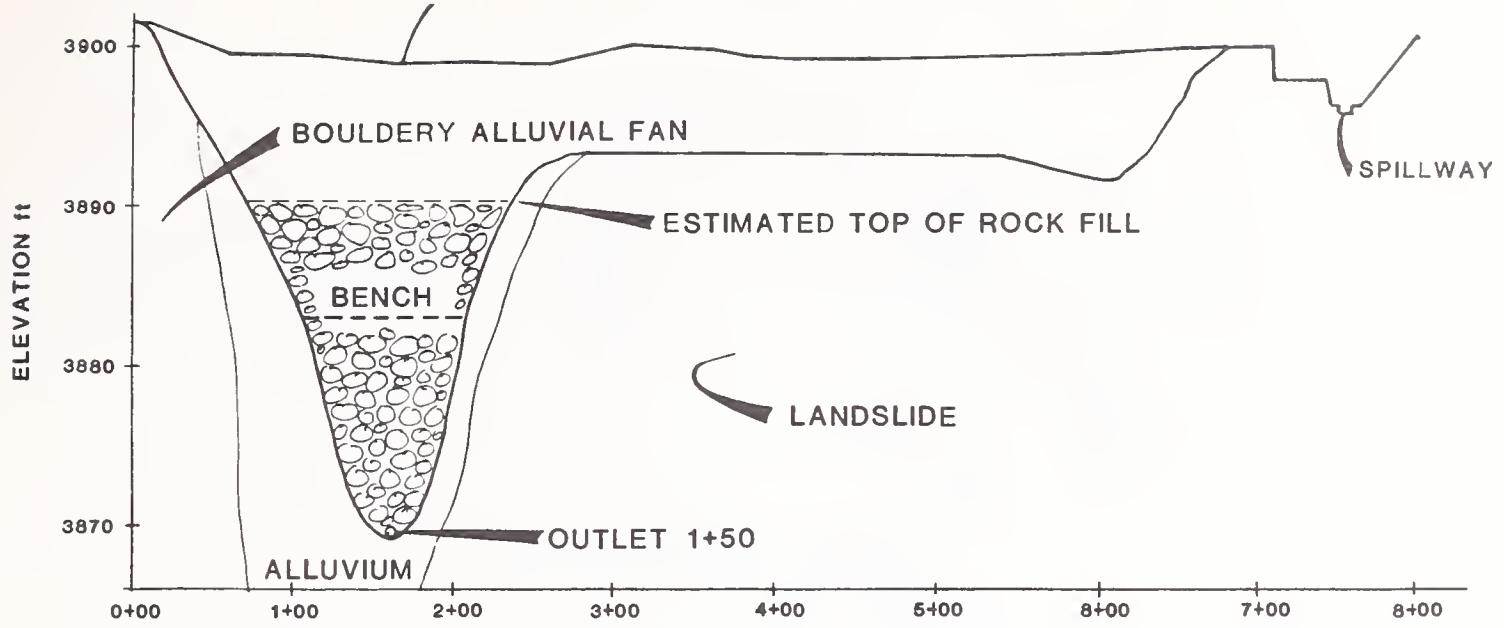
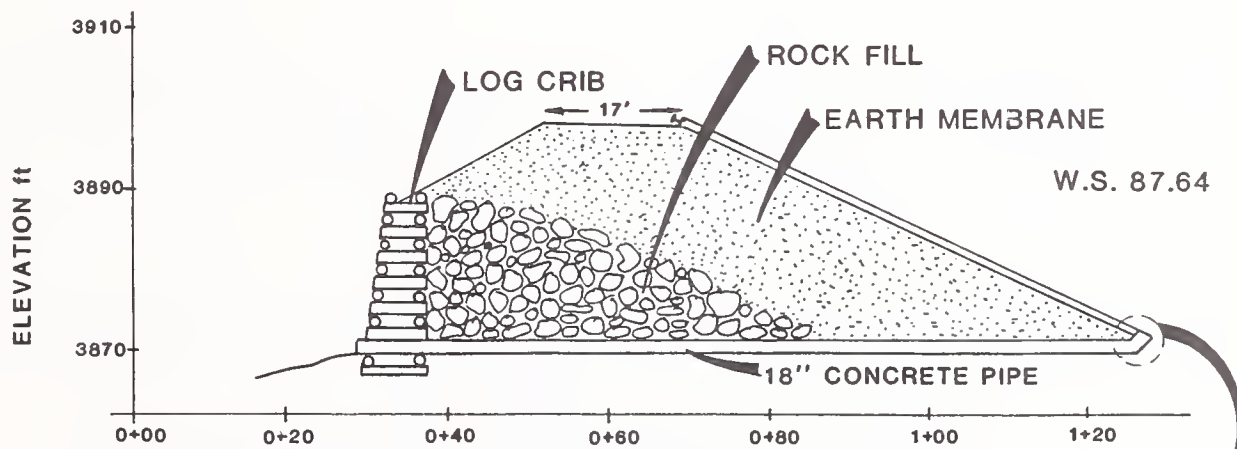
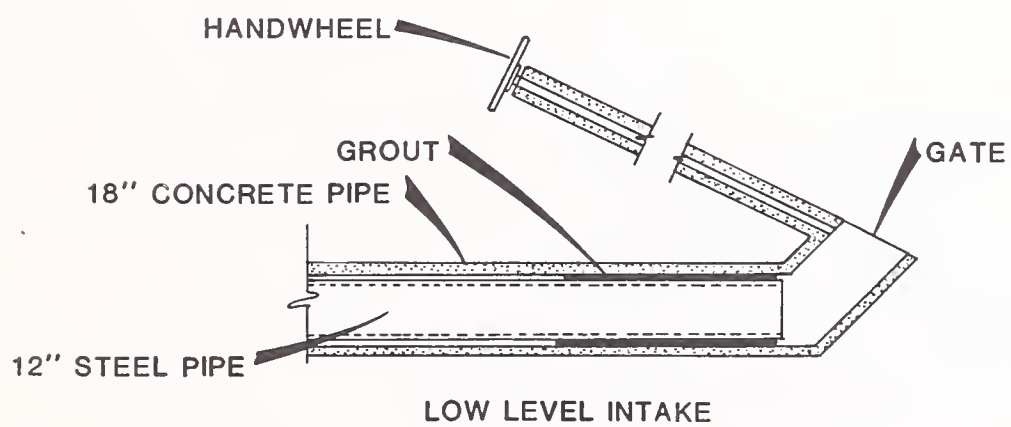
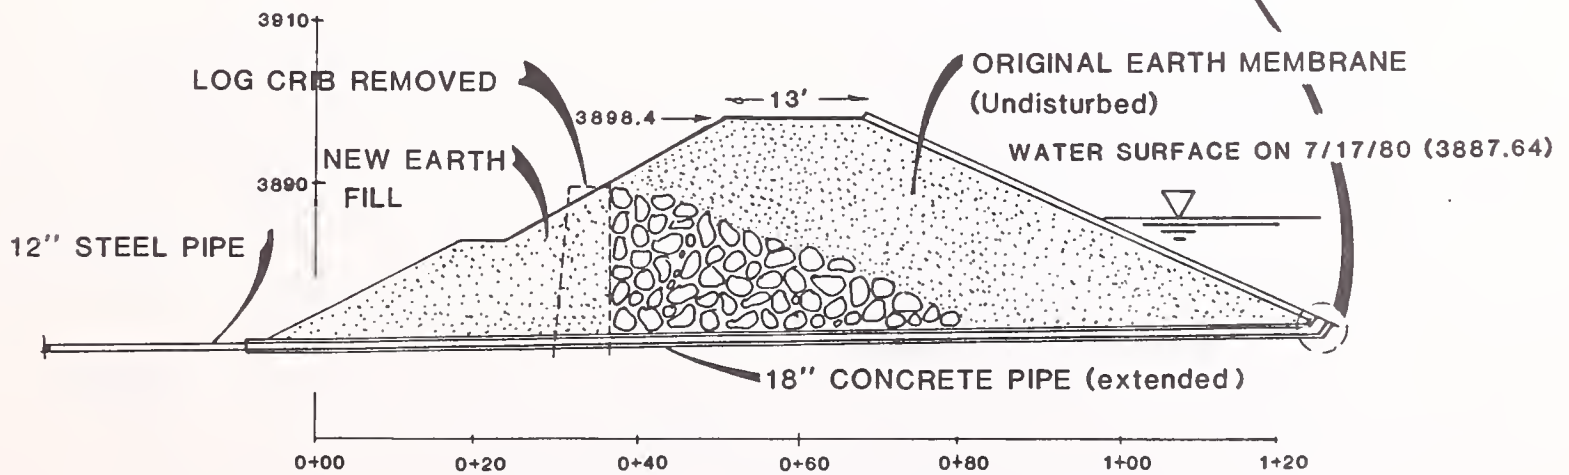
DAM PROFILE AND CROSS SECTION

The Wallace Creek Dam consists of an earth and rock fill dam section 240 feet long and 29 feet high with a connecting earthfill dike about 10 feet high which extends another 500 feet. The crest varies from 11 to 13 feet wide. The downstream face of the embankment is somewhat irregular due to modifications but has an average slope of about 1V on 1.75H. The exposed portion of the upstream face is concave and averages about 1V on 2.25H. As described by the owner the original 1922 embankment consisted of a log crib against which rock fill (granodiorite boulders from the right abutment area) was placed on the upstream side in the vicinity of stations 0+00 to 2+40 (Plate 4). The crib and rock fill extended to an approximate elevation of 3890.0 feet. The rock fill was covered by earth fill borrowed from the landslide deposits on the south abutment and placed by horse drawn scraper. The earth fill was placed on top and on the upstream side of the rockfill. The log crib on the downstream side of the embankment remained exposed. The earth fill comprised the remainder of the embankment above elevation 3890.0 feet including the dike.
